BRITTLE MATERIALS DESIGN, HIGH TEMPERATURE GAS TURBINE

CERAMIC TURBINE ROTOR TECHNOLOGY

13TH INTERIM REPORT FOR THE
PERIOD OCTOBER 1977 — MARCH 1978

Arthur F. McLean, Robert R. Baker

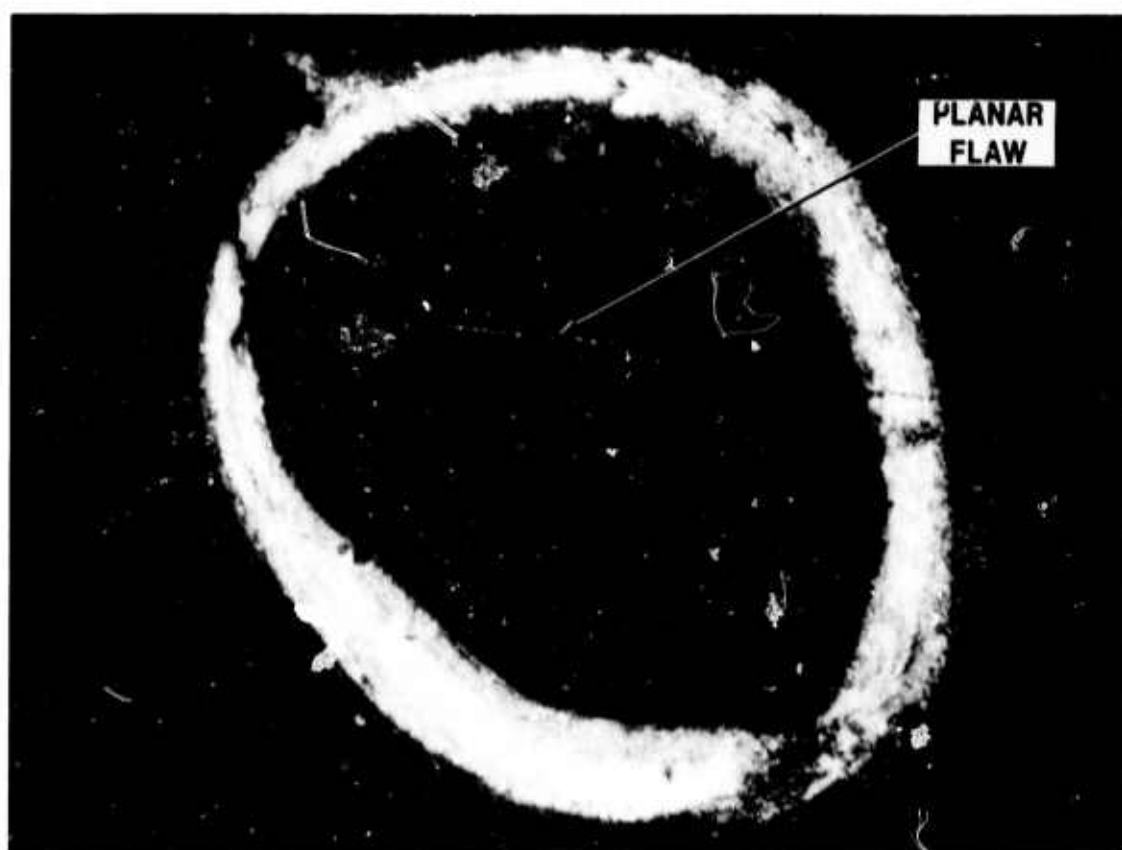
Figure 4.18 Planar Type Defect Detected by Visual Inspection

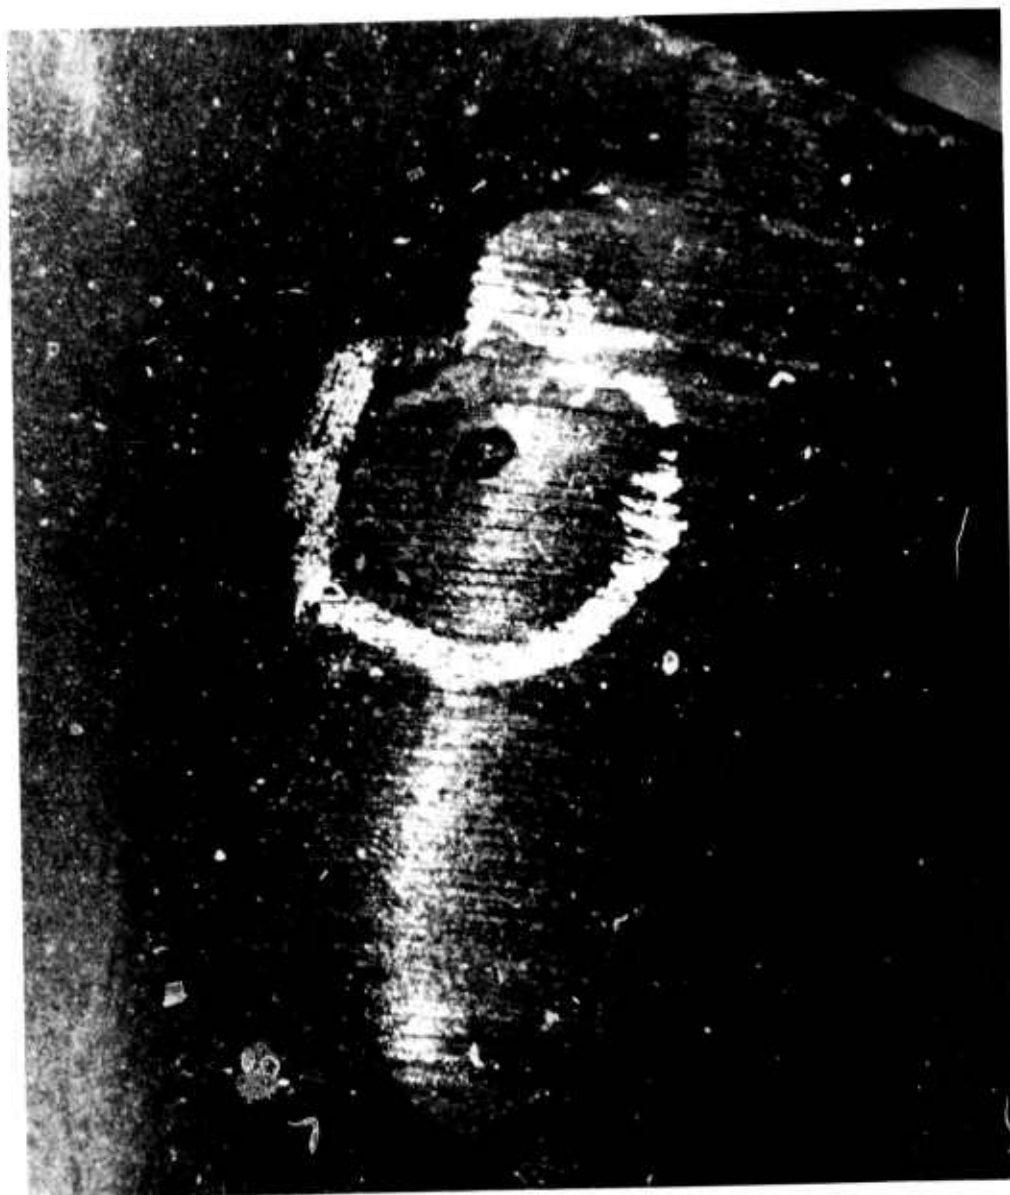
**Figure 4.21 Subsurface Void in Reaction Bonded Silicon Nitride Blade
Uncovered by Grinding**

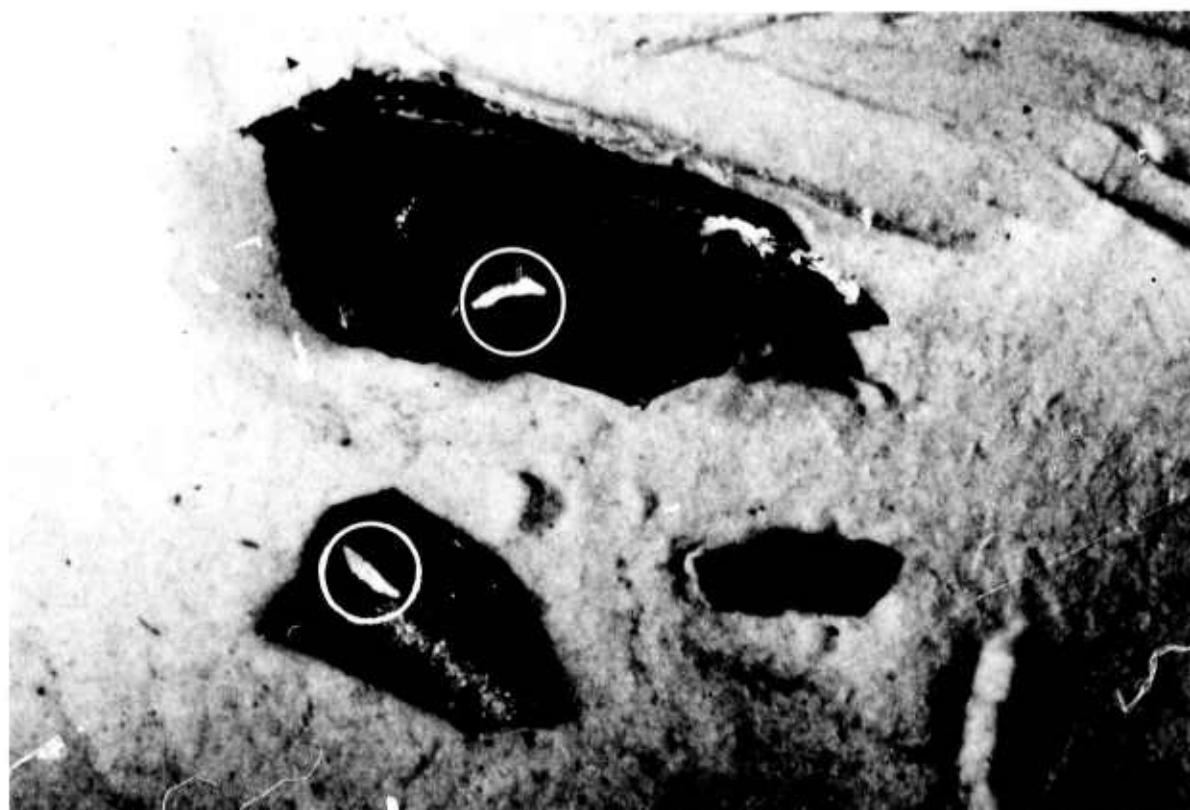
Figure 4.25 View of Planar Flaw After Fracture of Blade
